COMPENDIUM OF POST-FAILURE ANALYSIS TECHNIQUES
FOR COMPOSITE MATERIALS

RAY GROVE, BRIAN SMITH
BOEING MILITARY AIRPLANE COMPANY
P. O. BOX 3707
M/S 73-43
SEATTLE, WASHINGTON 98124

JANUARY 1987

INTERIM REPORT FOR PERIOD JULY 1984 - NOVEMBER 1986

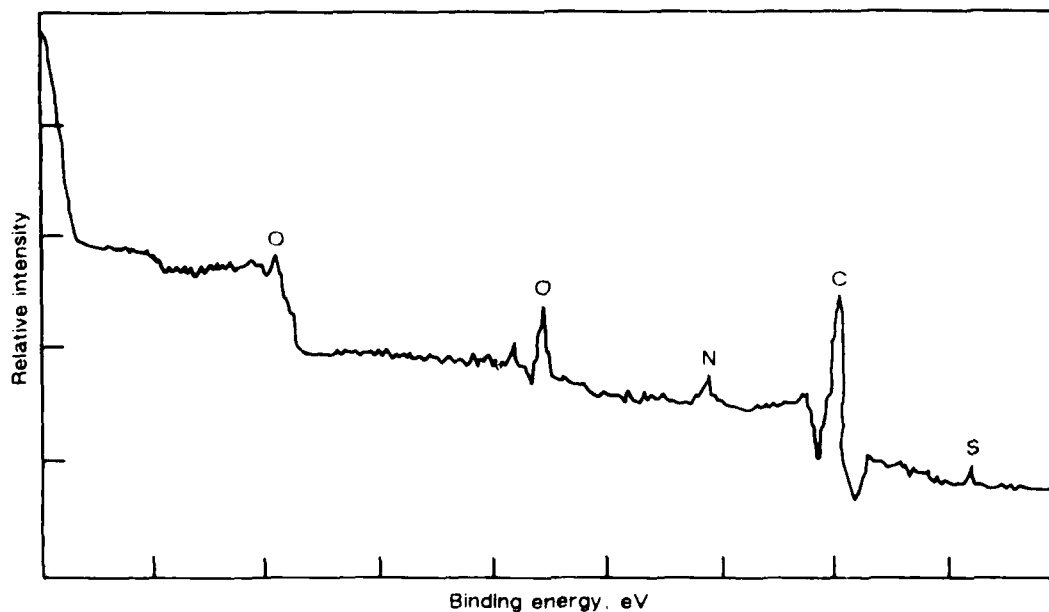
5-B70227-149

Figure 3-36. A Typical XPS Spectrum of an Epoxy Resin With Elements Identified

The binding energies of some typically encountered elements are listed in Figure 3-35. Figure 3-36 is a typical spectrum of an epoxy resin where the elements carbon, nitrogen, oxygen and sulfur are shown. If one is examining a fracture surface for a chemical contaminant, comparison of the surface relative to a fresh cohesive resin fracture surface will provide a very sensitive test for the presence of foreign elements indicative of contamination.

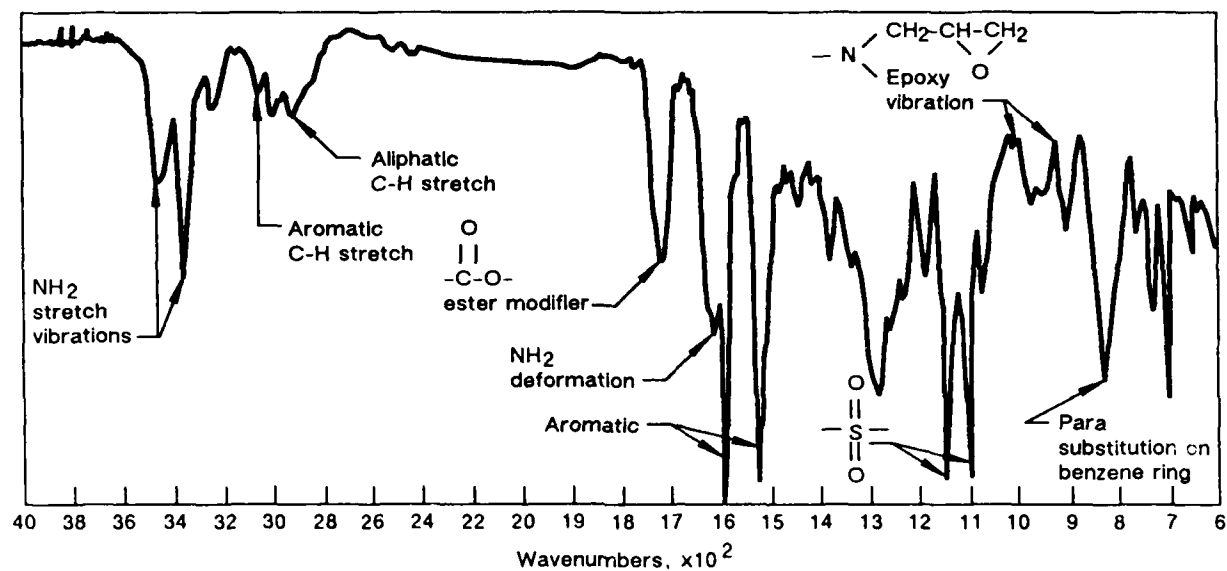
5-B70227-135

Figure 3-40. Infrared Spectrum of an Epoxy Resin

Organic polymer molecules absorb infrared radiation at frequencies which relate to the chemical bonds within the molecule. The physics of this process can be attributed to a mechanism where the infrared light is absorbed at discrete frequencies associated with characteristic molecular vibrations within the molecule. This principle forms the basis of Infrared Spectroscopy as an analytical technique to characterize polymer resins. Each polymer molecule absorbs infrared light in a distinctive pattern which can be used to fingerprint the molecule. Figure 3-40 illustrates a typical IR spectrum of an epoxy spectrum. In a contamination analysis where one is investigating an unknown identification, it is useful to compare the spectrum of the unknown with infrared spectra of model compounds published in an atlas or stored in a data base. Infrared spectra are usually plotted as intensity versus wavenumber (CM-1), wavelength (micrometers or microns), or frequency (s-1).

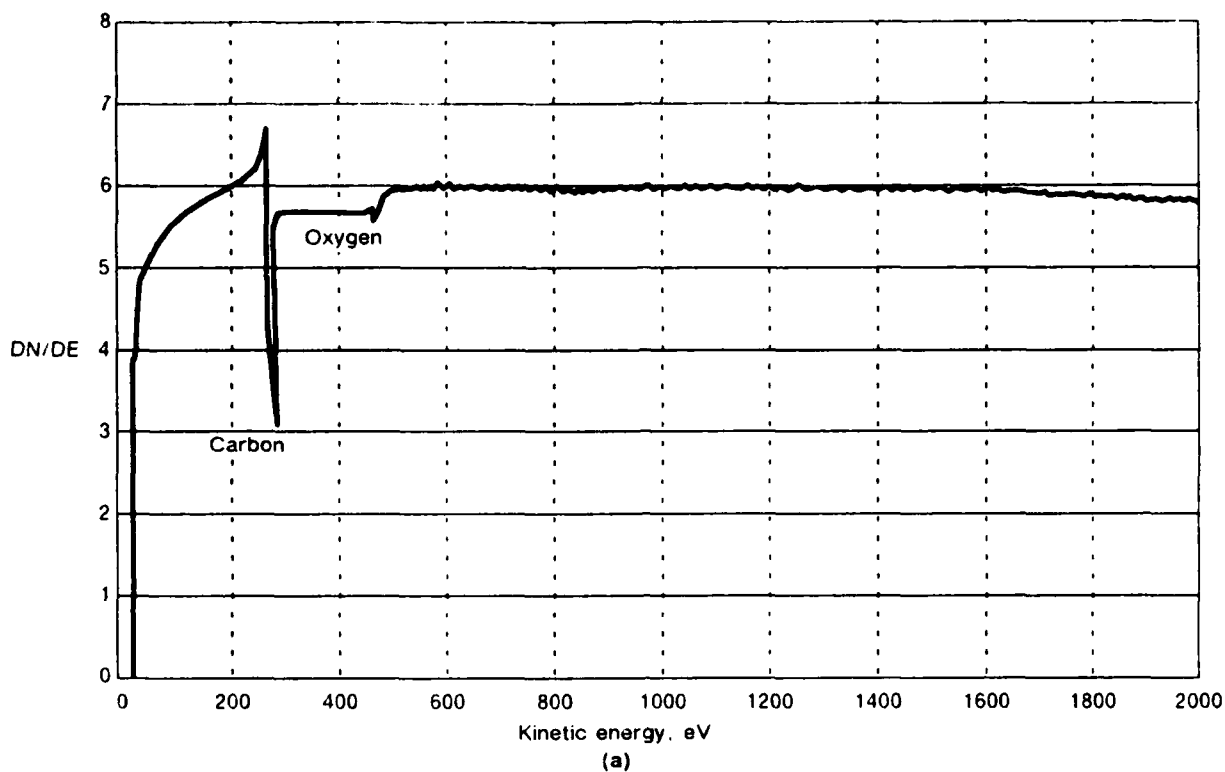
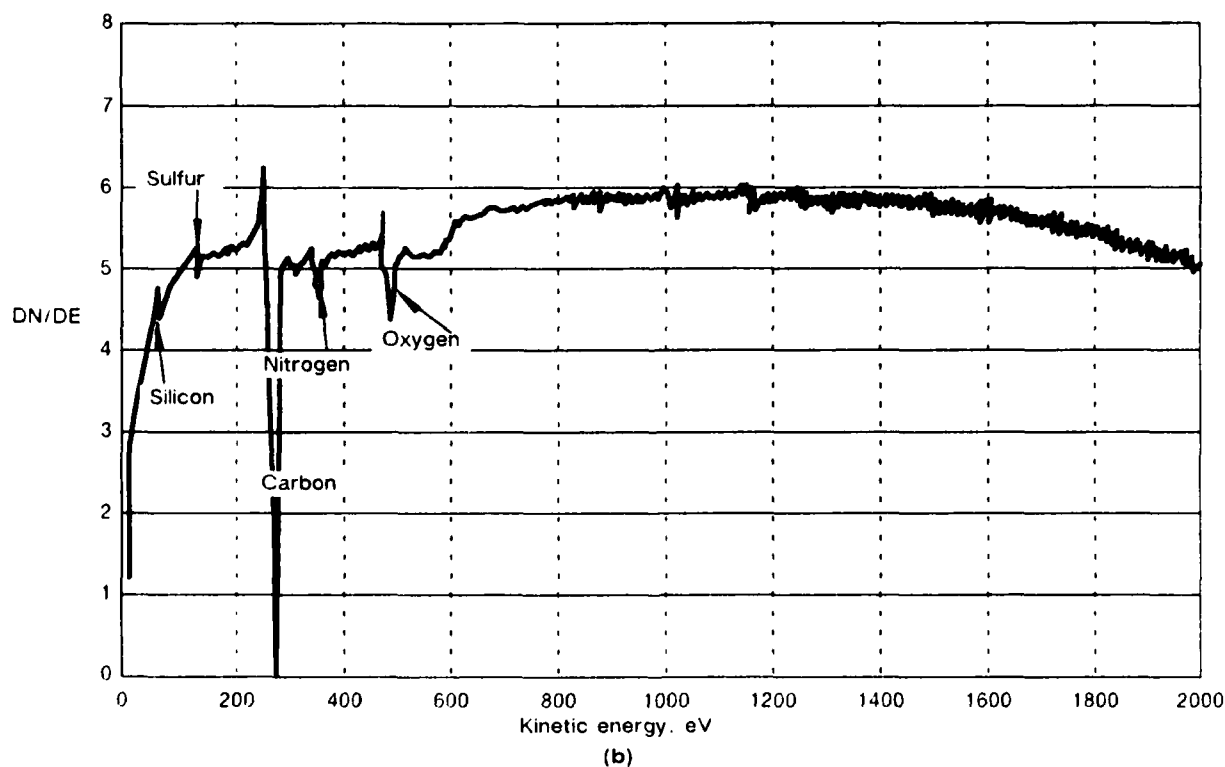
5-B70227-136

Figure 3-41. AES Spectra of (a) Carbon Fiber and (b) An Exposed Carbon Fiber on a Tensile Fracture

Auger Electron Spectroscopy (AES) is a surface analysis technique based on electron beam induced Auger electron emission, characteristic energy for each element, and escape from the surface in a manner analogous to XPS. In fact, many surface analysis instruments are designed to perform AES and XPS with the same spectrometer. Since AES requires a conducting specimen its applications are limited in composite analysis. However since the carbon fibers are conductive, AES can be useful in determining whether an exposed carbon fiber failed at the fiber matrix interface or in the resin. The analysis is based on the elemental differences between the fiber and the surrounding resin (which may be a sizing resin different from the nominal epoxy resin composition) as shown in Figure 3-41.

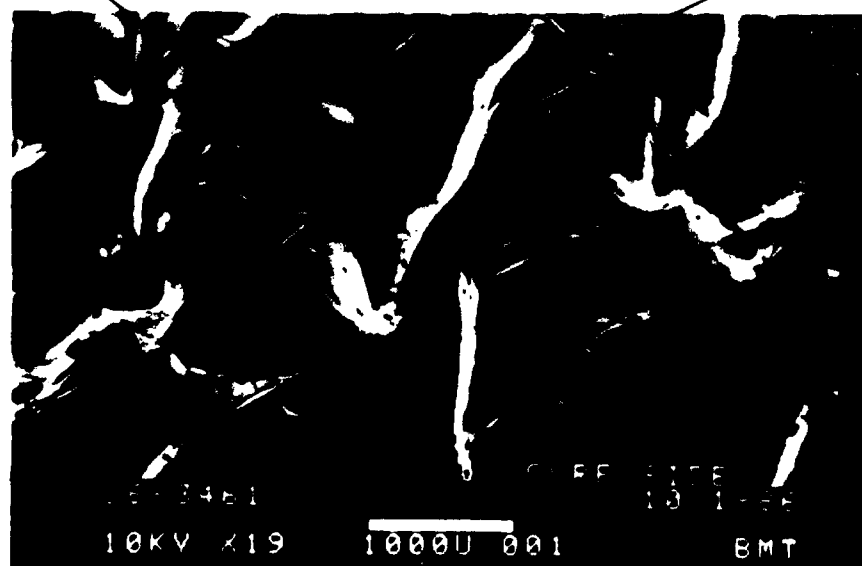
5-B70227-13

Mating features

Scrim impression

Figure 3-43. SEM Micrographs Showing a Replicated Surface Morphology

A secondarily bonded composite structure was returned from service after visual inspection revealed surface cracks on the outer painted skin surface. The composite construction had a laminated skin bonded to a honeycomb core. The bonding adhesive was a FM-300 adhesive. When the composite part was sectioned, it was noted that the paint cracking resulted from the skin buckling away from the honeycomb. An optical cross section is shown in Figure 3-42. Optical microscopic examination revealed the FM-300 adhesive separated along the centerline of the adhesive layer. SEM micrographs of mating separation surfaces are shown in Figure 3-43. The smooth surfaces lack any significant evidence of fracture features or resin deformation, indicating that a low energy adhesive failure had occurred. The adhesively separated surface followed the contoured boundary between two plies of adhesive. The mating surfaces are perfect replicas of each other. Even the protruding scrim fibers of one ply made an impression on the other ply without showing any evidence of bonding.

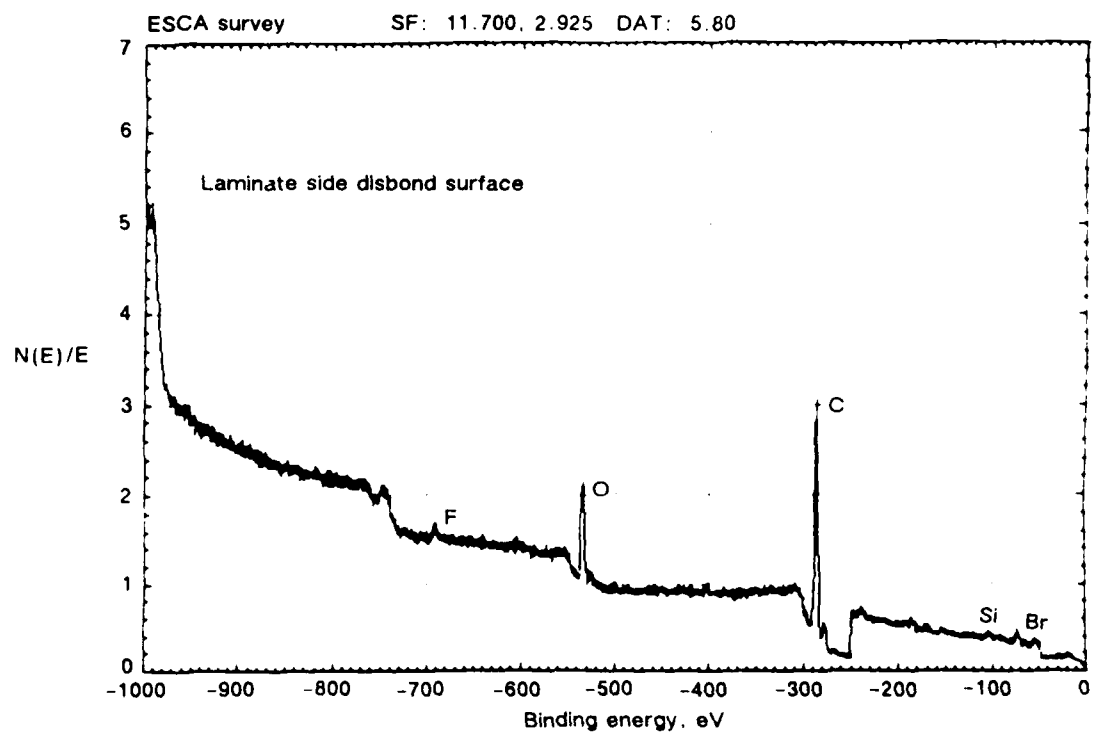
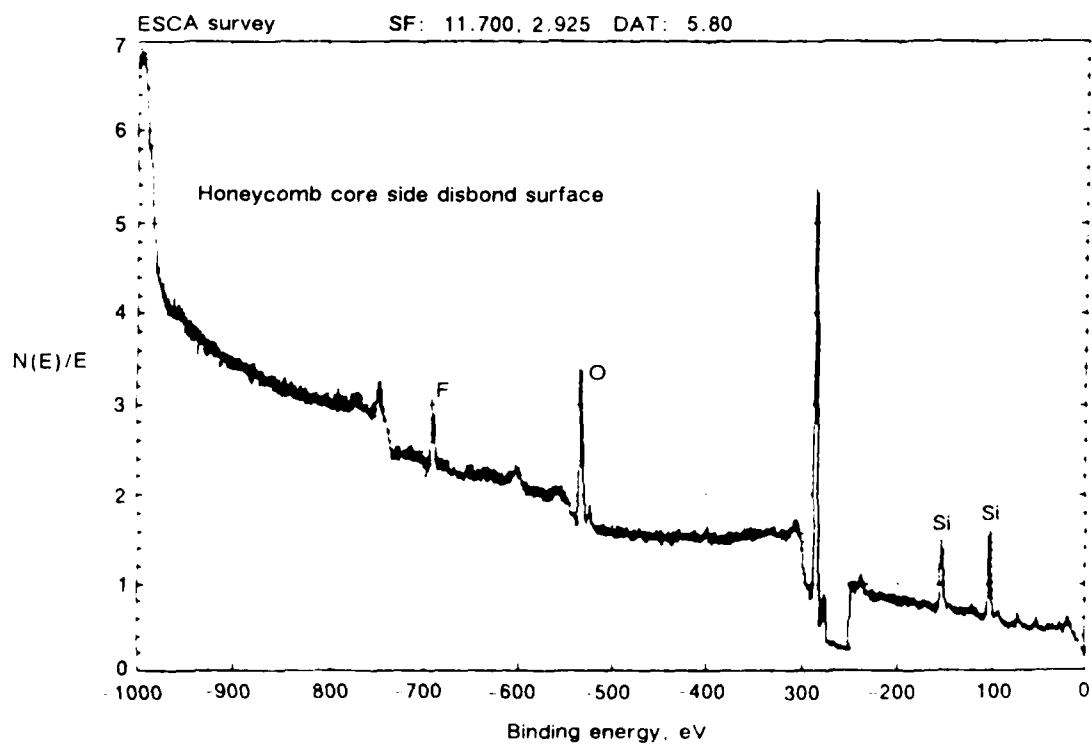
5-B70227-137

Figure 3-44. XPS Spectra of the Disbonded FM-300 Ply Surfaces

The XPS spectra of the debonded surfaces shown in Figure 3-44 revealed a significant amount of silicon, fluorine and carbon in addition to the expected composition of the adhesive. XPS peak shifts indicate the presence of silicone, fluorocarbon, and hydrocarbon chemical functional groups. The next step was to rinse the fracture surfaces with methylene chloride solvent and allow the soluble residues from the surfaces to precipitate on a salt pellet. The residue was then analyzed with the FTIR where hydrocarbon oils were identified in the spectrum. It was important to remember that these surfaces may have experienced a significant exposure to contaminants from the service environment. Because the SEM micrographs implied the weak boundary layer was present during the curing of the adhesive by the presence of scrim fiber impressions on the mating adhesive plies, the contaminant must have been present during manufacturing and curing of the bondline.

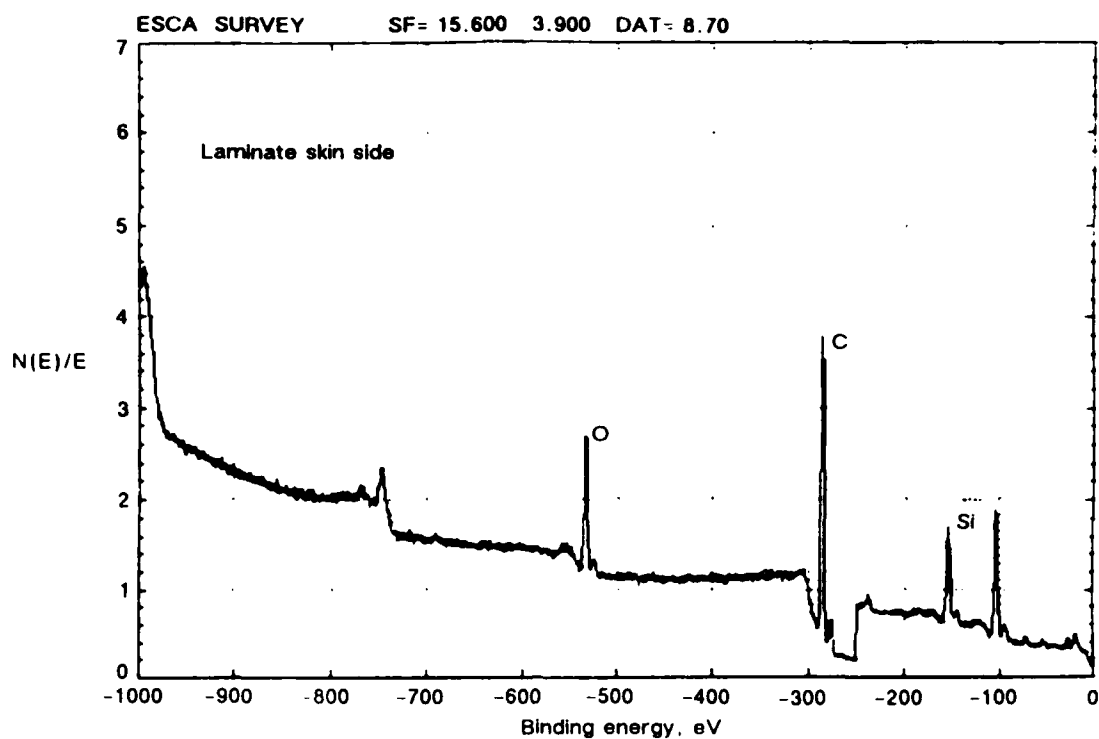
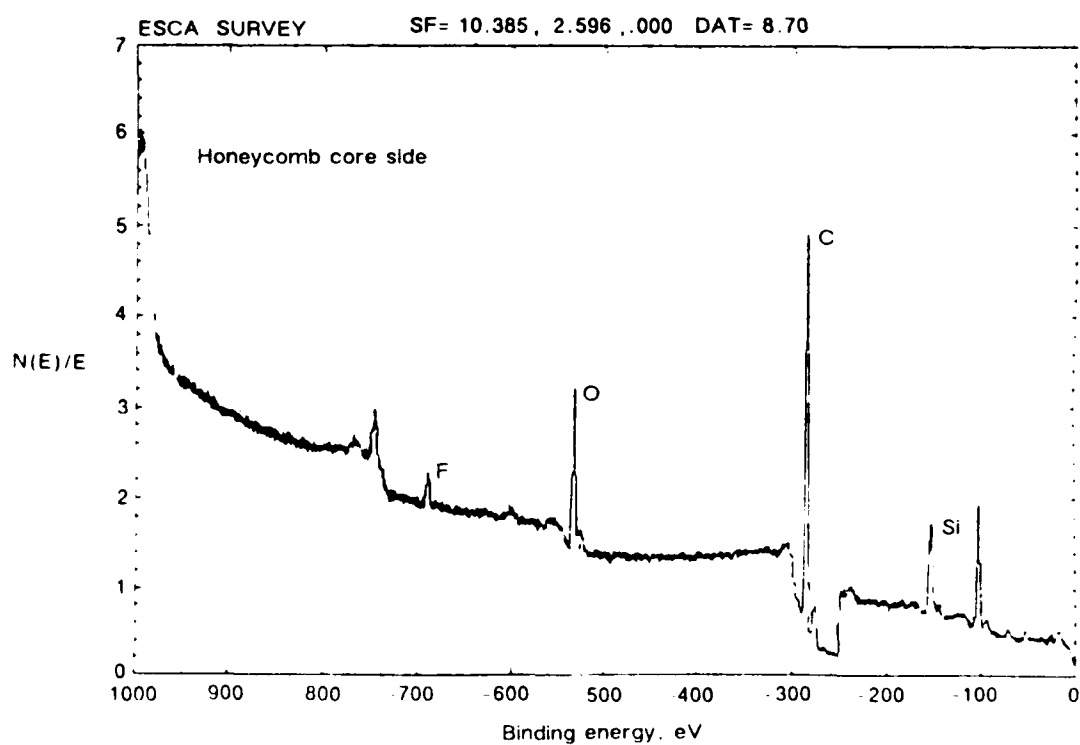
5-B70227 138

Figure 3-45. XPS Spectra of FM-300 Ply Surfaces Separated by Hand in the Laboratory

Using this assumption, areas of the composite part with similarities of location and construction (the disbond occurred adjacent to a core dropoff) were examined for bondline integrity. To ensure that no secondary contamination would occur, the part was cut with hand shears (cleaned in a solvent) which produces very little particulate damage. The part was also cut in the analytical lab well away from fabrication and machining areas where contaminants can be easily introduced. The result was that the adhesive bondline was easily separated by hand after being cut out with the shears. Separation occurred in a similar manner at the interface between the two adhesive plies and the mating surfaces were smooth and featureless. The advantage of finding these weak boundaries is that the specimen can be separated and introduced into the XPS spectrometer within minutes thereby ensuring that any contaminant found is directly related to the original debonding. Figure 3-45 shows the XPS spectra in which the primary contaminant is silicon with the appropriate shift expected for a silicone release agent. Subsequent FTIR analysis of the soluble residues rinsed from the surface did not detect any anomalous functional groups, which implies the contamination is very minute.

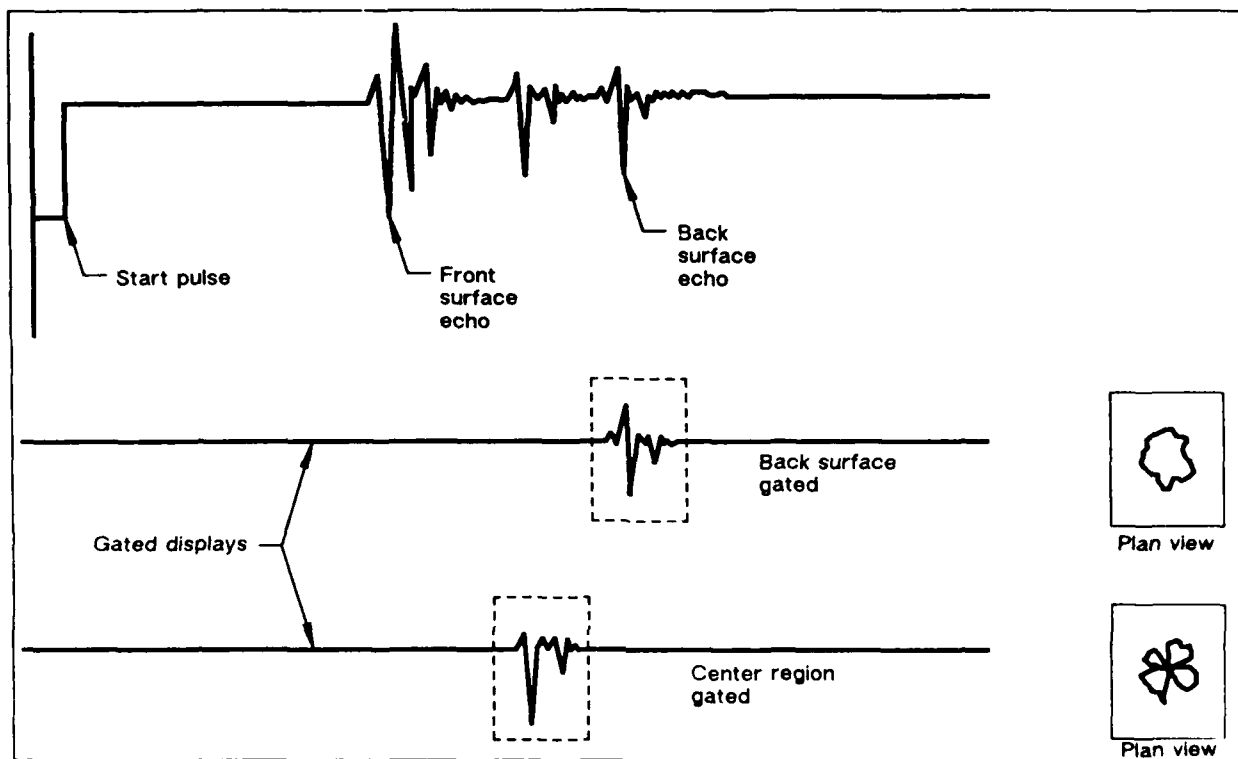
5-B70227-145

Figure 3-49. Pulse-Echo Ultrasonic C-Scan Using Time Domain Gating Zones To Identify Damage States of Impact

For use in the C-scan format, the inspection is usually performed in either a water bath or by using columns of water sprayed upon the surface of the specimen. The water serves as the coupler and delay line for the ultrasonic signals. Information is generally recorded in which the signal levels at each (and time or depth) is printed or displayed as the transducer is moved over the specimen. The C-scan pulse echo is a plan view, two dimensional image of the internal structure of a material. With gating of the amplitude based digital signal, imaging of defects can be identified related to the position within the thickness of the material, as shown in Figure 3-49. The use of a combination of two gating zones can allow the differentiation of delaminations near the front surface (light) and the back surface (dark).

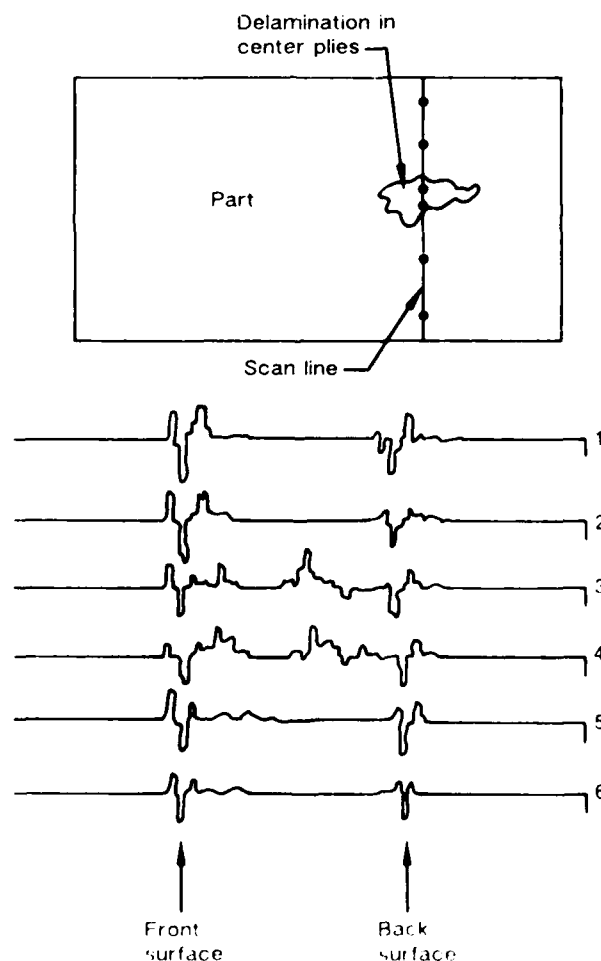
5 B70227-146

Figure 3-50. Delamination Identified by a Family of Pulse-Echo Ultrasonic A-Scans

Short pulse (shock wave) methods can also produce a considerable amount of information, although it is limited to linear plotting of the data instead of the two dimensional C-scan. In A-scan, the reflected pulses can be real-time displayed on a cathode ray tube or permanently recorded. By comparing the reflected pulse information from a region of damage with an area containing no damage (often a calibration sample), the depth of the defect condition can be fairly accurately determined. Similar to C-scan, this method produces an image delineating the reflections between the front and back surfaces. By taking several parallel passes of the transducer over the part, a better feeling of the three-dimensional geometry of the defect can be obtained, as shown in Figure 3-50.

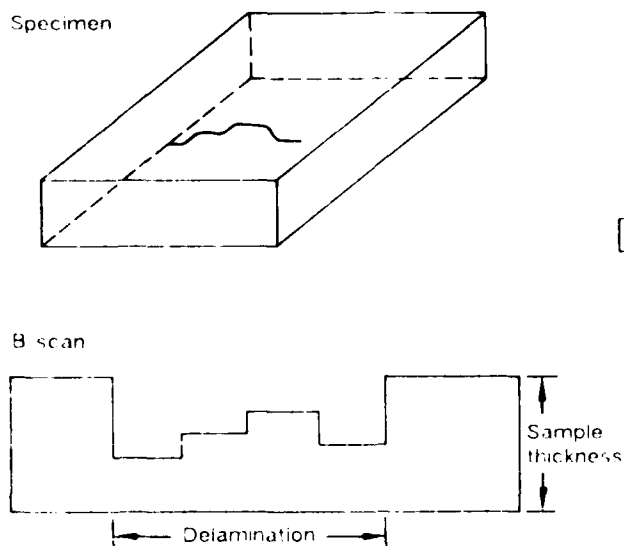
5-B70227-147

Figure 3-51. Pulse-Echo Ultrasonic B Scan of a Delamination Defect.

is somewhat similar to a transverse cross-section, in that it provides a record of the depth location on a line across the specimen surface. By taking several of these scans, they also can be combined to provide a more complete view of the through-thickness damage in the material. An example of a B-scan is presented in Figure 3-51, illustrating the extent of damage in a laminate at several locations along the surface of the part. For field or initial inspections, the A-scan method using a cathode ray tube for imaging can be performed without a permanent record of the damage. For instance, early NDE investigations in large failed structures with visible damage and delamination, hand-held pulse-echo can be used to quickly define the perimeter of the delamination damage. In this case the couplant is usually a light grease, oil, or commercially available gel.

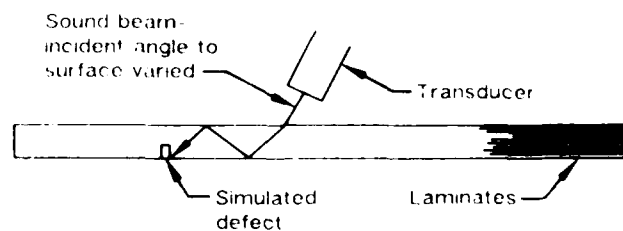
5-B70227R1-148

Figure 3-52. Ultrasonic Detection of Simulated Crack in Laminate Plate

Recent developments have provided a method of identifying transverse cracking, with resolution capable to identify cracking within a single ply. This technique is usually called single-sided ultrasonic angle beams (backscatter) and involves using an off-axis transducer that imparts the sound at an angle to the surface, as shown in Figure 3-52. This technique employs separate transmitting and receiving transducers housed in a single surface probe. A complex wavefront is created in the structure by the transmitter, and is continuously monitored by the receiving transducer. With this system, delaminations create both a phase and amplitude change, allowing their detection. Because the ultrasonic signal is

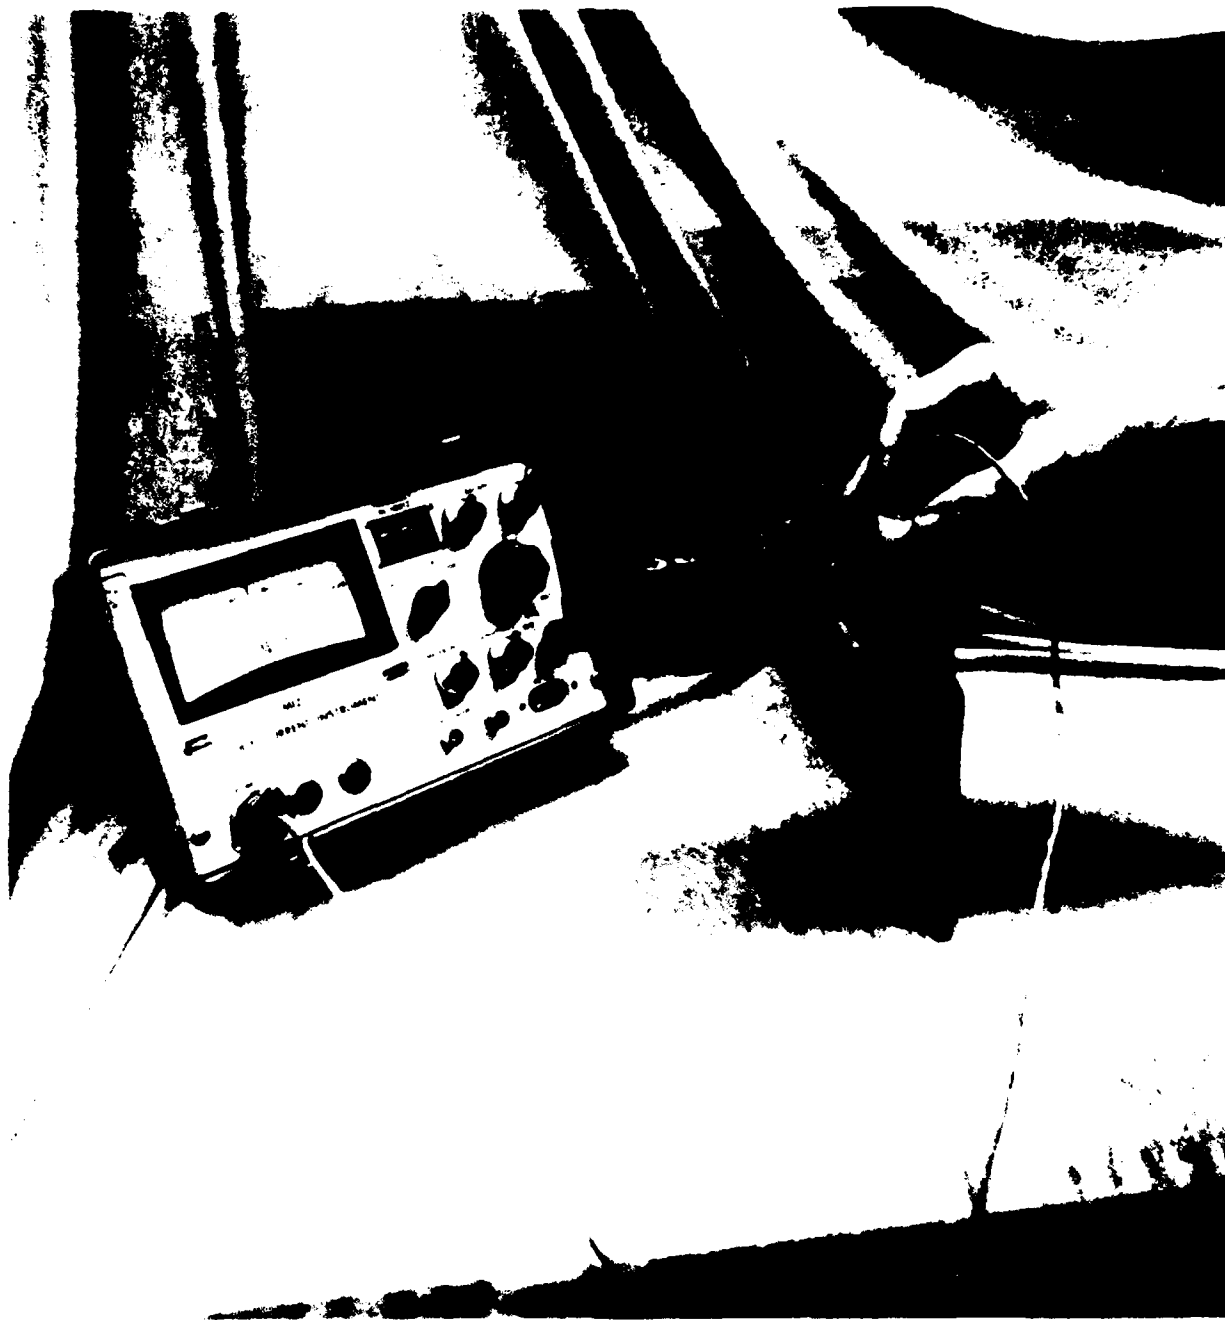
5-B70227-20

Figure 3-54. Subsurface Fracture Evaluation

This technique is commonly used in metals and has provided satisfactory results for fabric laminates, particularly for locations around small, localized geometric variances such as fastener holes and edge radii. Eddy current testing involves small, hand held surface probes that produce an alternating magnetic field. This field is generated by an alternating current test instrument coil. This alternating expanding and collapsing current induces a magnetic eddy current in the specimen. The interaction of this magnetic field with the test instrument varies as the internal flaws and fractures are encountered. The use of this instrument is basically limited to solid laminates that are conductive and have appreciable magnetic permeability. This method relies on the conductivity of the carbon fiber, which is at best, limited. Figure 3-54 presents a typical inspection procedure using a probe to detect subsurface damage in fabric laminates.

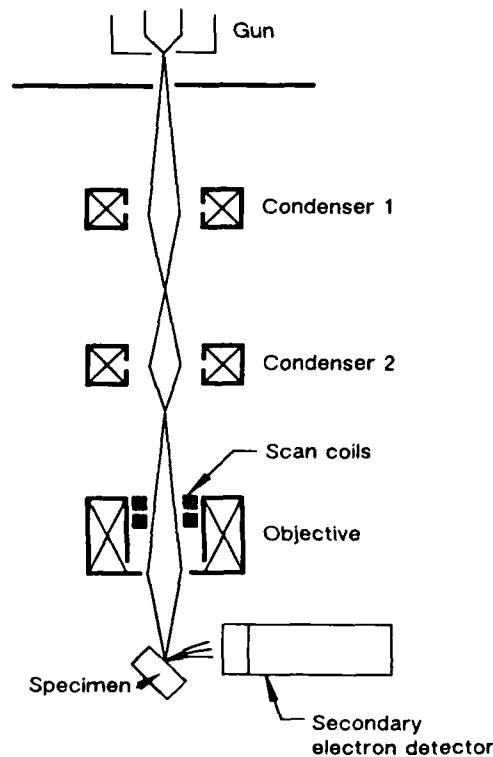
Figure 3-58. Basic Features of the SEM

3.3.4.2 SEM Techniques

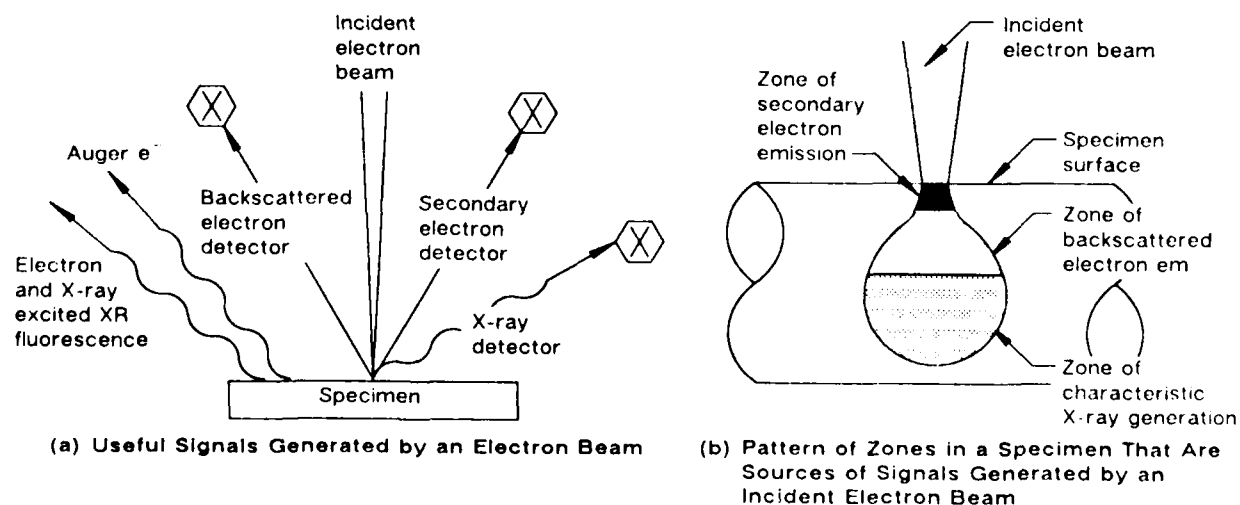
Figure 3-59. The SEM Beam-Specimen Interaction Details

When the primary electron beam is impinged upon the specimen, electrons and other radiations are emitted from the surface that can be used to produce images and to microchemically determine the elements present. Figure 3-59 shows the types of emissions radiated from the surface and the relationship to the type of detection modes available. The most common detection modes for composite materials are: (1) the secondary electron (SE) mode, (2) the backscatter electron (BE) mode, (3) the psuedo backscatter electron (PBE) mode, and 4) X-ray spectroscopy. These are used routinely with a sound understanding of the types of information available and the limitations of each detection mode. Each of these detection techniques are described below except X-ray spectroscopy, which is presented in paragraph 3.1.

As shown in Figure 3-59, the backscatter electrons are produced by single large-angle or multiple small-angle elastic scattering of the primary electrons as they impact the atoms from 0.1 to 1.0 μm beneath the surface of the specimen. Different than secondary electrons, the energy distribution of the backscatter electrons depend directly on the energy of the primary electrons and the atomic number of the material. In a similar manner, although with a more pronounced effect, surface inclination of the specimen provides an accentuation of the topographical features of the specimen. In specimens with high atomic numbers, which have larger atomic sizes, a larger percentage of the electrons are backscattered from atoms closer to the surface, with little change in energy. Therefore, the yield and thus the brightness is increased with materials that have higher atomic numbers. For those specimens which have a very smooth topography, the use of pseudo-backscatter electron is employed. This involves using the secondary electron detector with gating of the allowed electron energies for those electrons with more than 50 eV. This detection mode does not "see" the secondary electrons that have energies around 3 eV. Figure 3-60 illustrates the use of secondary, backscatter, and pseudo-backscatter for the imaging of a composite fracture surface.

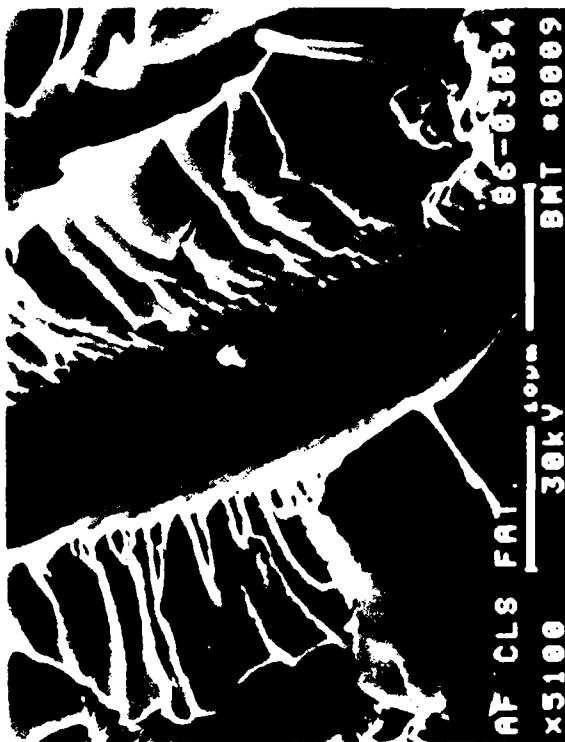
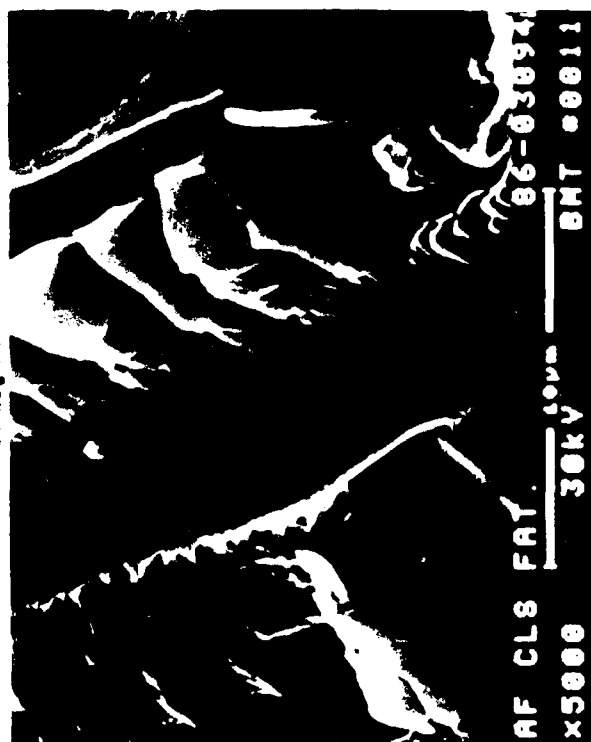
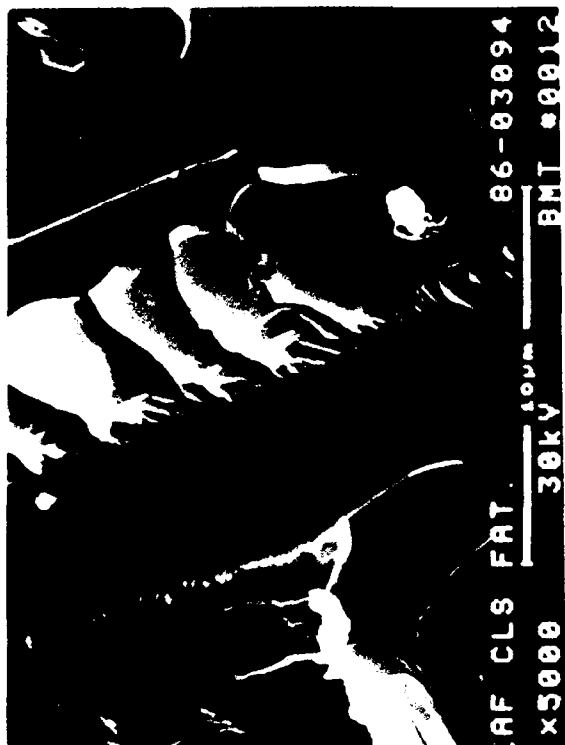
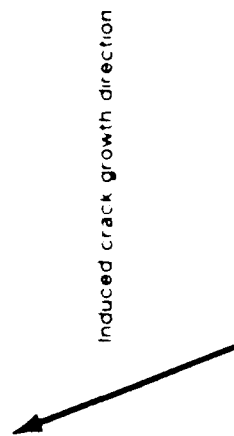
Figure 3-61. SEM Photomicrographs of Effect of Tilt on Striation Resolution

30-deg tilt

0-deg tilt

Induced crack growth direction

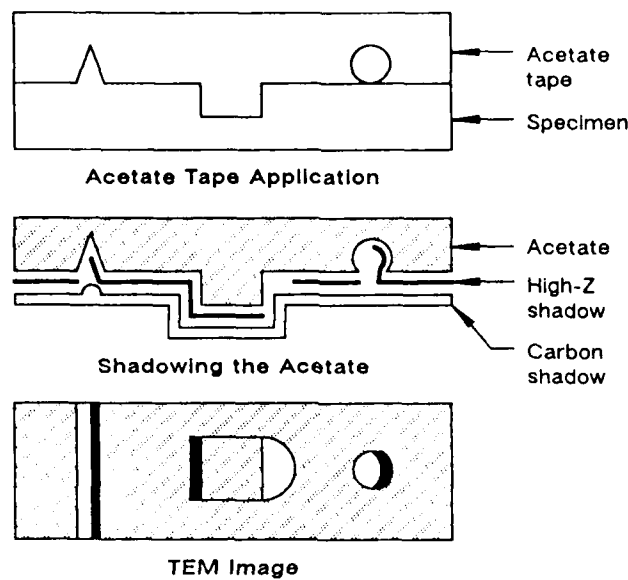
Figure 3-63. The Two-Stage TEM Replication Technique

Following the generation of several clean replicas, they are then prepared in the same manner that is used for metals, in which the plastic replica is first shadowed with a high Z (atomic number) material such as germanium, and then coated with carbon. Figure 3-63

illustrates the two stage replication technique. For fatigue striation evaluation and maximum enhancement of the subtle features involved, the direction of germanium shadowing should be parallel to the direction of anticipated fatigue crack growth.

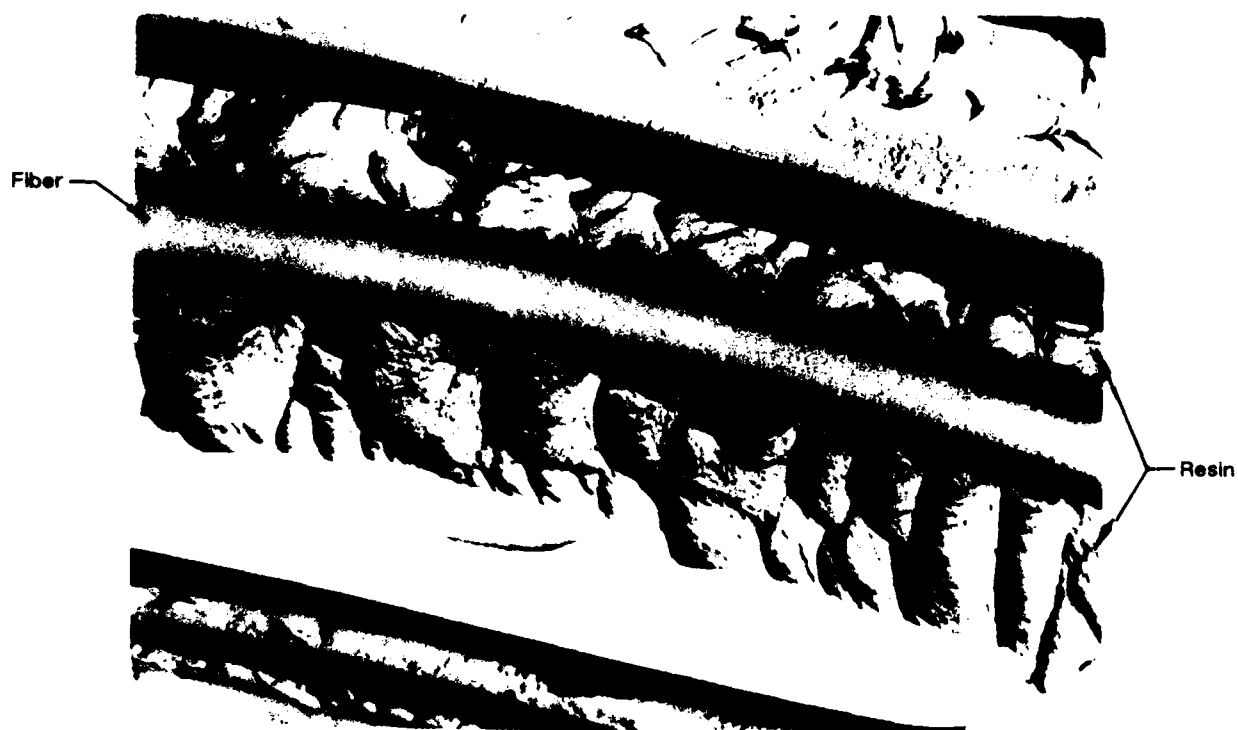
Figure 3-66. TEM Photomicrograph of Striation Features From a Crack Lap Shear (CLS) Specimen

Note the curved striations equally spaced along the fiber surface

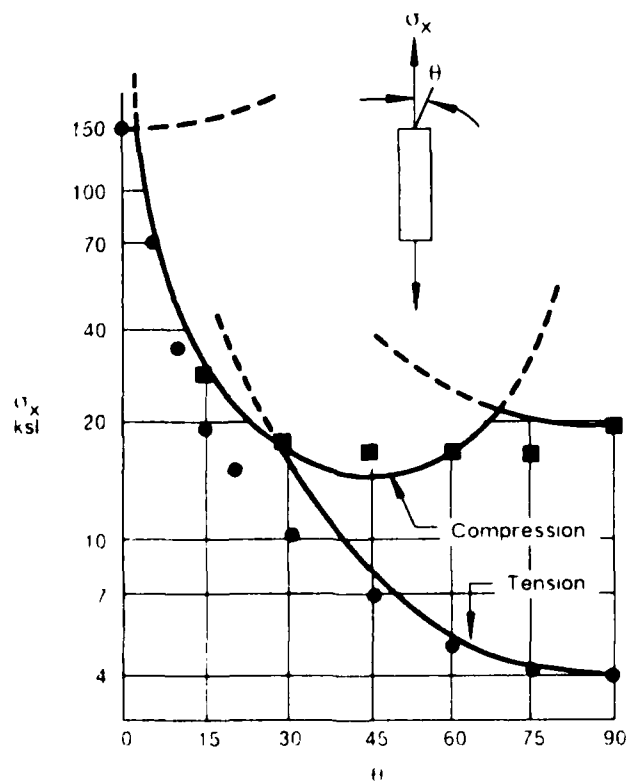
Figure 3-70 Maximum Stress Failure Theory

An analogous failure criterion in terms of strains (see ref. 11) generates strength predictions in close agreement with the maximum stress theory. Figure 3-70 illustrates data taken by Tsai (ref. 16) that shows there are significant discrepancies between theoretical strength predictions based on the maximum stress failure criteria and experimental data for glass/epoxy. This is expected since interactions between stress components are not accounted for.

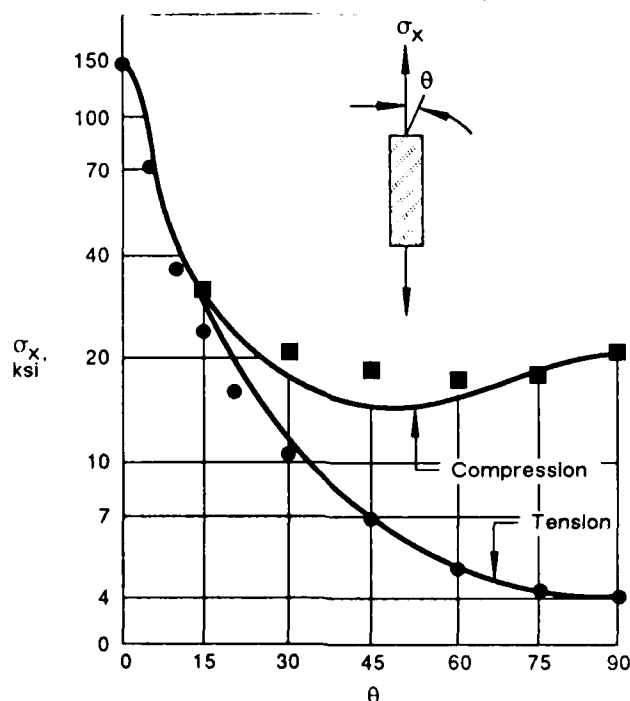
Figure 3-71. Tsai-Hill Theory

The Tsai-Hill strength criterion for uniaxial loading of an off-axis ply is developed by substituting equations (9), (10, and (11), into equation (12). The resulting criterion shown below provides an excellent fit to the experimental data for glass/epoxy (ref. 16) as shown in Figure 3-71.

It should be noted that the Tsai-Hill criterion provides for interactions between stresses and yields a smooth curve when compared to the maximum stress or strain criteria. However, von Mises isotropic yield criterion and hence the Tsai-Hill theory is related to distortional energy as opposed to dilatational (volume change) energy. The disadvantage to Tsai-Hill's criterion is that biaxial loading of orthotropic materials always causes distortional and dilatational energy. Hence failure may not be directly related to distortional energy as it was for isotropic materials. A more general strength criterion including additional interaction terms is discussed in the next paragraph.

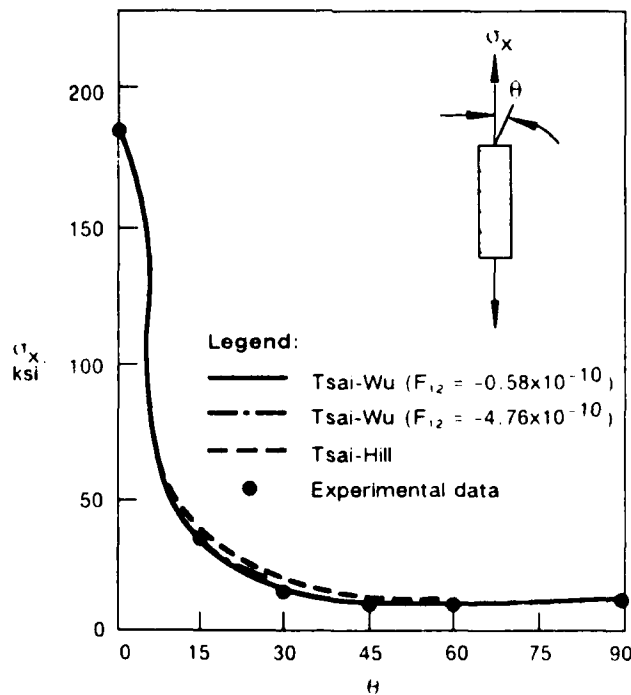
Figure 3-72. Tsai-Wu Tensor Theory

This insensitivity is demonstrated in Figure 3-72 where predicted strengths are in excellent agreement with experimental data for boron/epoxy (ref. 18). Figure 3-72 also demonstrates that for uniaxial loading there is little difference between the Tsai-Hill and Tsai-Wu criteria. Although the Tsai-Wu strength theory is more complicated, the well founded mathematical operations of tensor theory can be used to transform the strength parameters in these equations. This is important since it leads to straight forward computer implementation. References 11 and 12 provide invaluable discussions and examples on the Tsai-Wu strength theories in terms of stress and an analogous strain criteria.

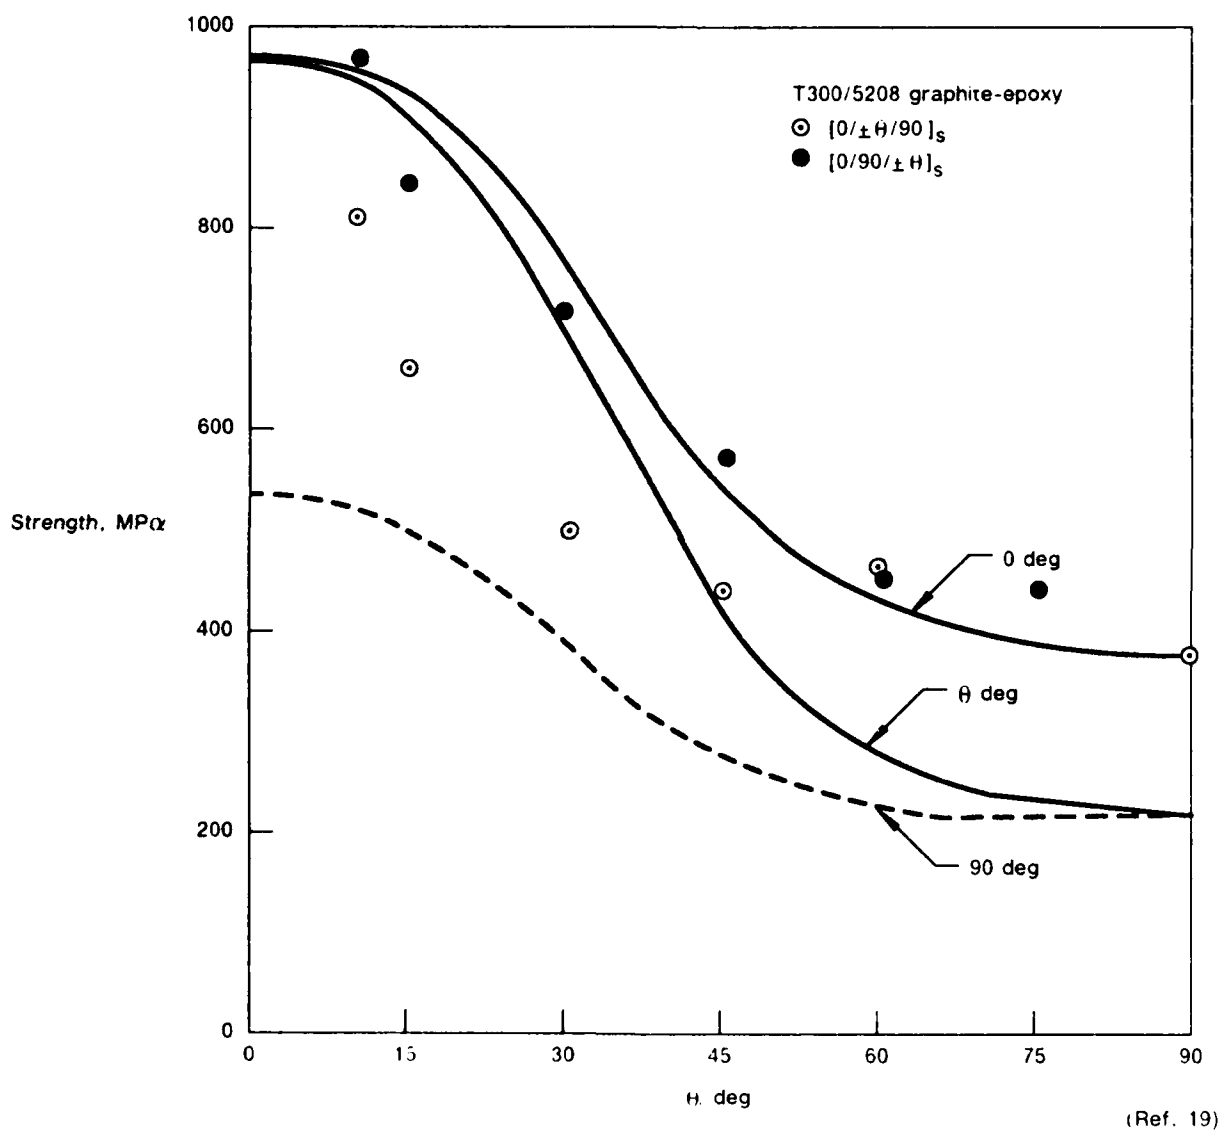
Figure 3-73. Comparison of Calculated Inplane Tensile Strength With Experiment

First Ply Failure—At some point during loading of a multidirectional laminate, the ply or group of plies with the lowest strength will start accumulating damage. This event, often described as first ply failure, can be predicted using the lamina level theories presented in paragraph 3.4. Figure 3-73 shows a comparison between predicted strengths for plies in a uniaxially loaded multidirectional graphite/epoxy laminate based on the quadratic interaction criterion (ref. 19). It is seen that first ply failure (that is, the 90 degree plies) occurs at a lower load level than catastrophic laminate failure. This is expected, since load shedding from the damaged 90 degree plies to the rest of the plies continues until the laminate cannot carry additional load. In this case, a more accurate, but nonconservative, prediction of the strength would be based on the strength of the 0-degree plies as shown in Figure 3-73. The first ply failure envelope for a multidirectional laminate is the intersection of the failure envelopes for each ply angle in the laminate. This is shown schematically in Figure 3-74 based on the quadratic interaction criterion and ply strength data from (ref. 11).
